# Mirror Edge Creep: Info & FAQ's

## What is Mirror Edge Creep?

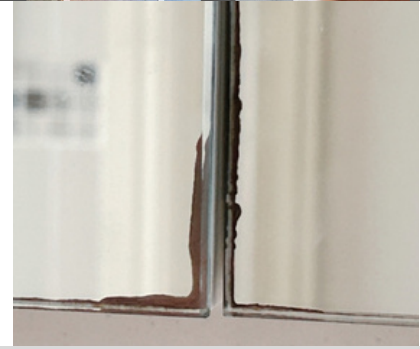
Mirror edge creep, also known as desilvering, is the gradual deterioration of a mirror's reflective coating, typically starting at the edges. It appears as unsightly black or darkened areas that slowly spread, diminishing the mirror's clarity and overall look. This issue is particularly problematic in high-moisture areas like kitchens, bathrooms, and laundries, where steam, water splashes, and cleaning chemicals can easily reach the edges of traditional mirrored splashbacks.

Mirror edge creep happens when the protective layers on the back of a mirror are compromised. This allows moisture and other environmental elements to reach the reflective silver coating, causing it to oxidise and lose its shine.
